PHASE I REPORT
NATIONAL DAM INSPECTION PROGRAM

NAME OF DAM: Glendale Dam
STATE LOCATED: Pennsylvania
COUNTY LOCATED: Cambria County
STREAM: Beaverdam Run, secondary tributary of the Susquehanna River
DATE OF INSPECTION: August 9 and 16, 1978

GLENDALE DAM
NDI I.D. NO. 912
AUGUST 9, 1978

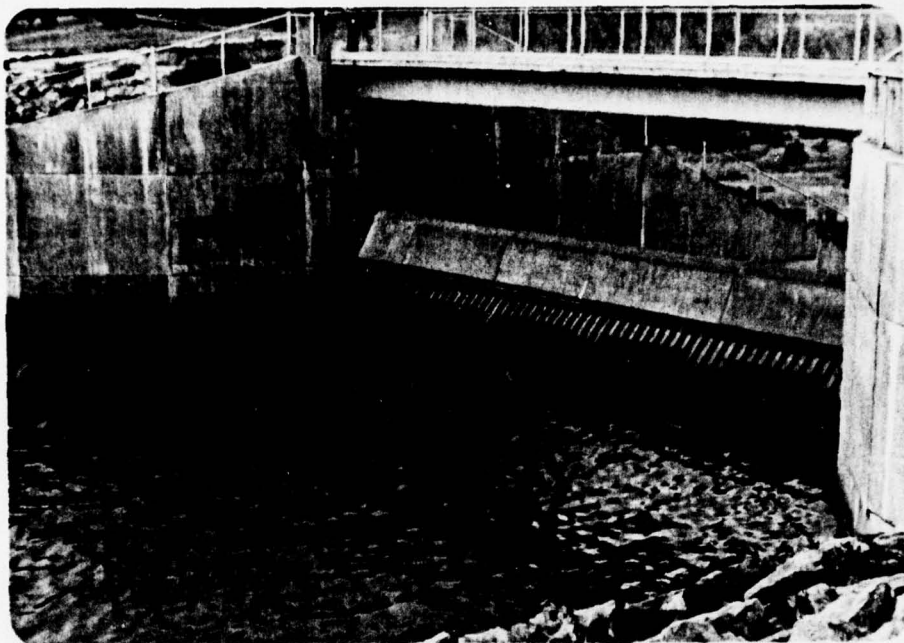
Photograph No. 3
Spillway crest.

VISUAL EXAMINATION OF	OBSERVATIONS	REMARKS OR RECOMMENDATIONS
CONCRETE WEIR	EMERGENCY: 60-FJ OGEE SECTION PRIMARY: 4-ORIFICES THROUGH OGEE SECTION (BOTH IN GOOD CONDITION)	
APPROACH CHANNEL	FREE OF DEBRIS. FLOATING TRASH BOOM WAS BROKEN.	
DISCHARGE CHANNEL	CONCRETE CHUTE. GOOD CONDITION.	
BRIDGE AND PIERS	BRIDGE ACROSS THE SPILLWAY (SEE PLATE B)

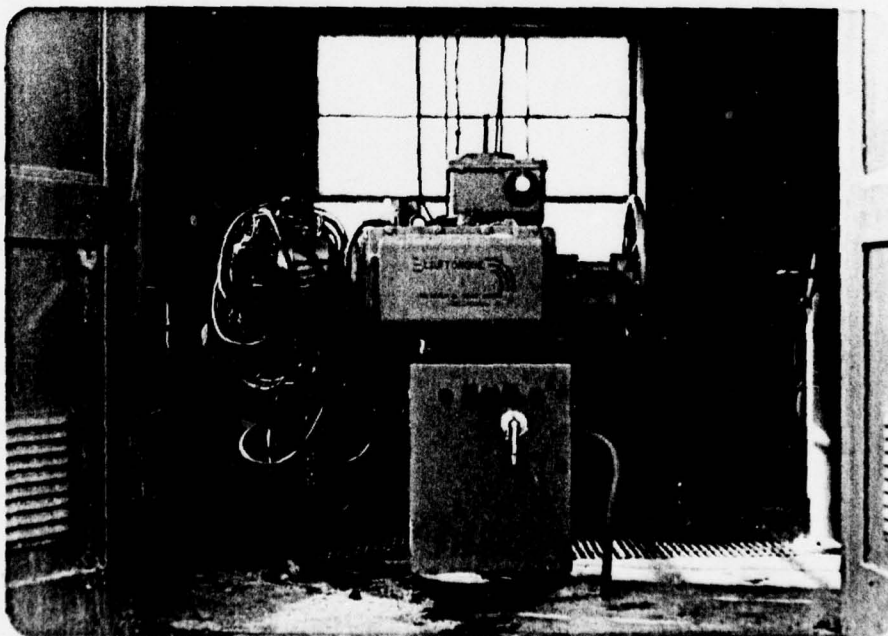
Photograph No. 6
Outlet pipe gate control.

The operation of the outlet pipe sluice gate was observed and found to be functional.

4.3 Maintenance of Operating Facilities. The maintenance condition of the operating facilities is considered to be satisfactory. The outlet conduit sluice gate was operated and observed to be functional.

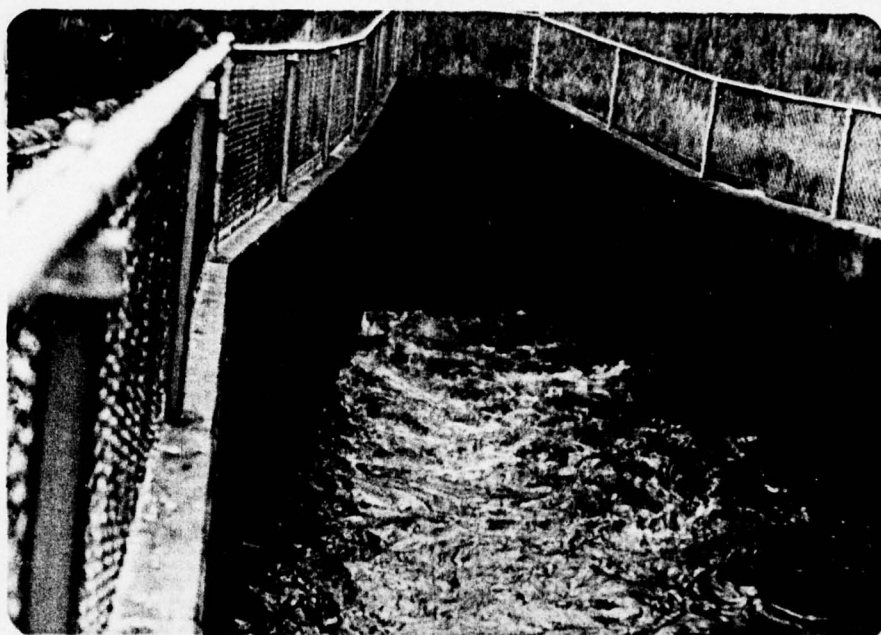
Photograph No. 7
Outlet pipe discharging.

3.2 Evaluation. The condition of the dam is considered to be good. The outlet pipe was half full due to the backwater from the stream. Therefore, the outlet pipe was not inspected. The acid mine drainage observed at the junction of the embankment and the left abutment at toe level is not considered to affect the overall performance of the dam at this time. However, this seepage should be monitored and recorded to determine that the flow is not increasing with time. The turbidity of the seepage should also be observed.

VISUAL EXAMINATION OF	OBSERVATIONS	REMARKS OR RECOMMENDATIONS
CRACKING AND SPALLING OF CONCRETE SURFACES IN OUTLET CONDUIT	5.5 FT X 6.0 FT HORSESHAPED CONDUIT. THE CONDUIT WAS HALF FULL DUE TO BACK WATER FROM THE STREAM. ∴ NO INSPECTED.	
INTAKE STRUCTURE	WET TOWER. VISIBLE PORTIONS IS IN GOOD CONDITION.	
OUTLET STRUCTURE	STILLING BASIN. GOOD CONDITION	
OUTLET CHANNEL	RIPRAPPED EARTH CHANNEL GOOD CONDITION.	
EMERGENCY GATE	OPERATED BY STATE PERSONNEL AND OBSERVED TO BE FUNCTIONAL. (MOTOR OPERATED SLUICE GATE)
